**Megalightning and
The Demise of STS-107
Space Shuttle Columbia**

*A Fresh Look
at the
Available Evidence*

© 2009 David B. Smith
(aka davesmith_au, davesmith1au)

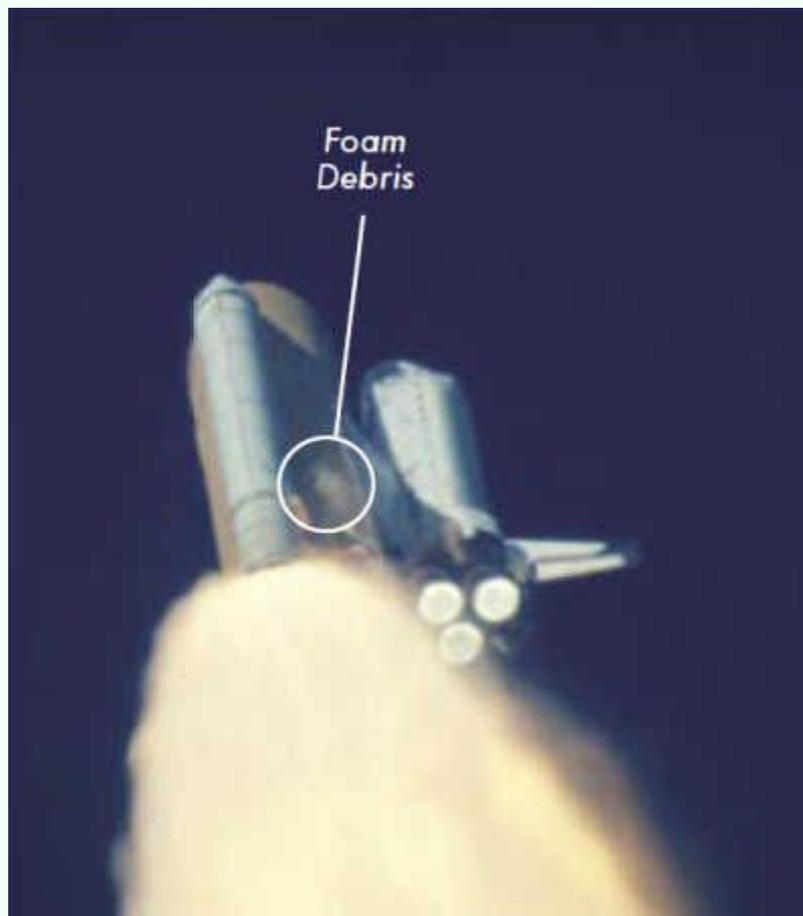
[Figure 2.a.1]

*A shower of foam debris after the impact on Columbia's left wing.
The event was not observed in real time.*

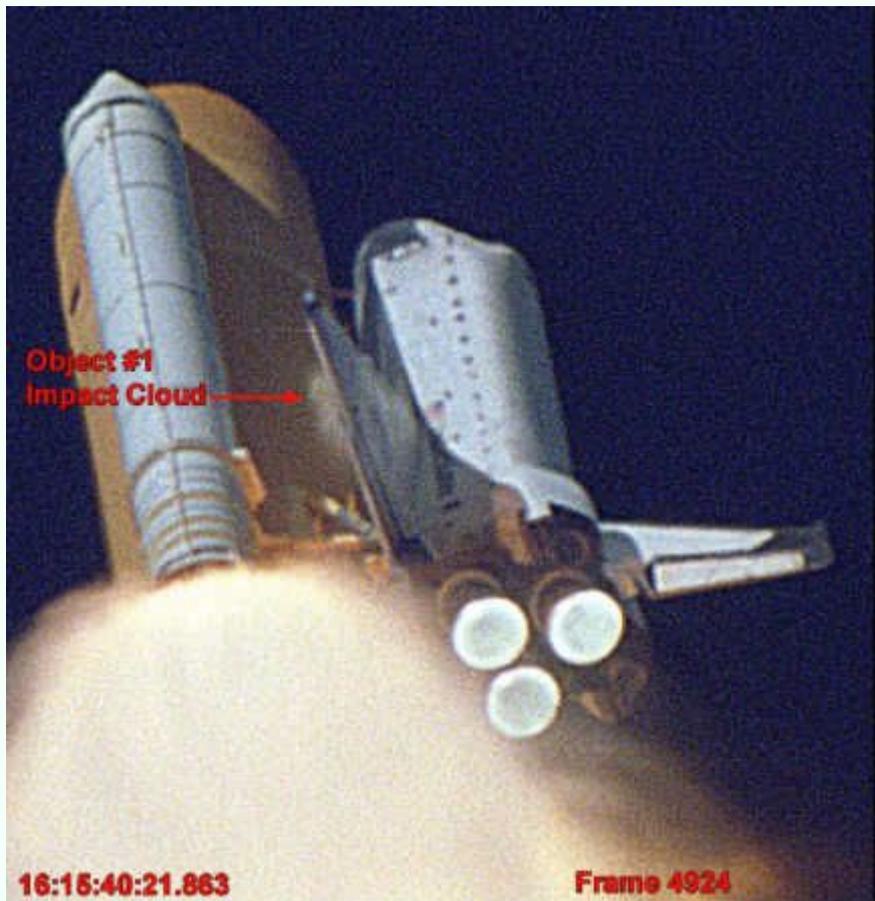
[Figure 2.a.2]

Only Object 1 was confirmed to impact the left wing. There is no conclusive evidence of more than one debris impact to the Orbiter. A large, light-colored cloud, which emanated from the underside of the left wing due to debris

Debris impact cloud seen on E-212 (Frame 4924)

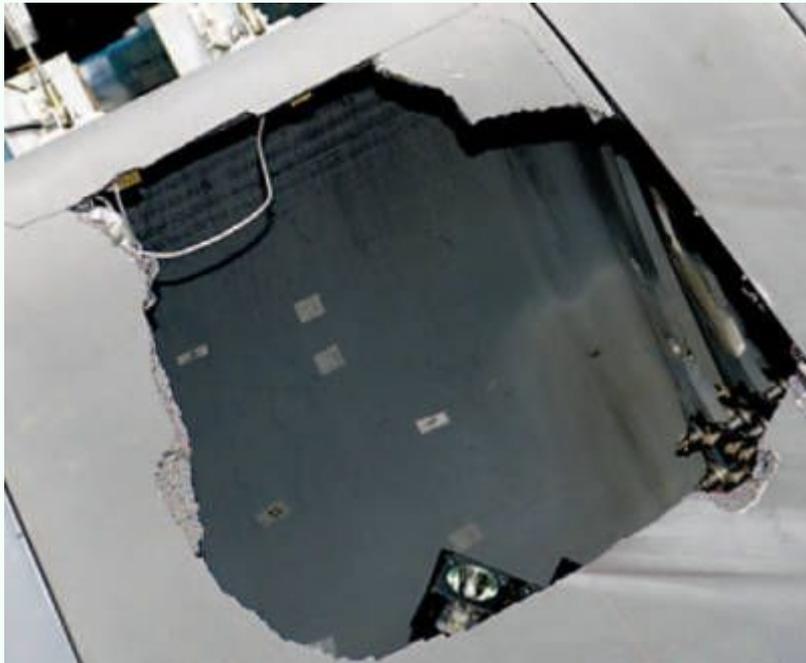
[Figure 3.b.2]

The large impact hole in Panel 8 from the final test.

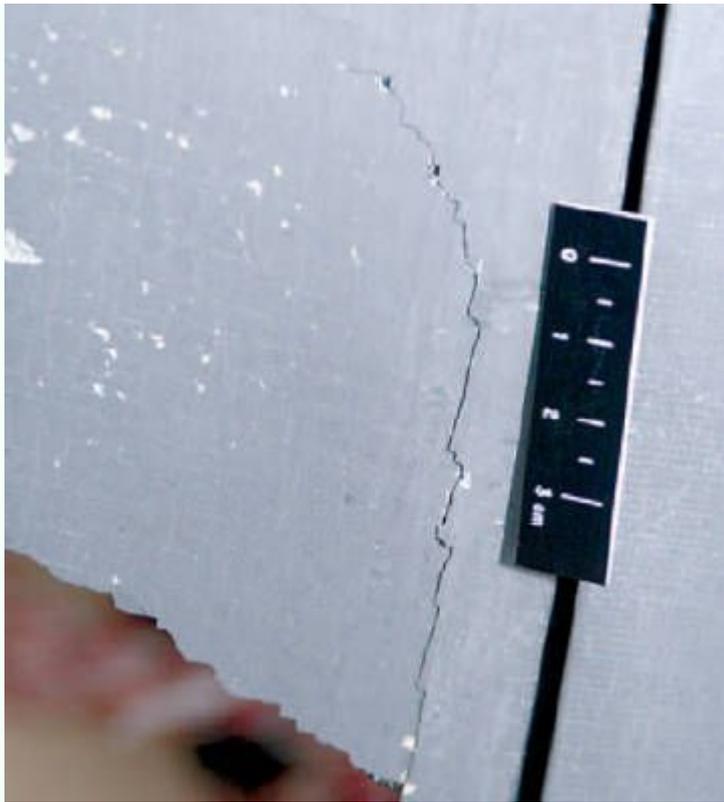
[Figure 3.b.3]

Numerous cracks were also noted in RCC Panel 8.

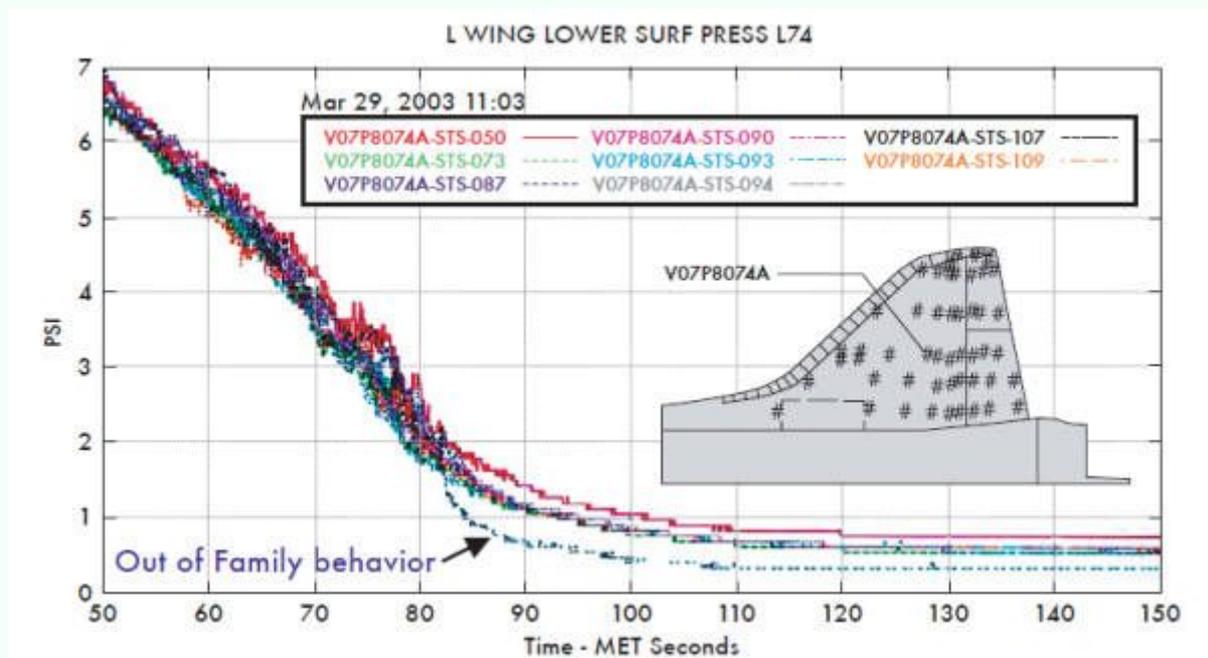
[Figure 3.c.2]

There are two other indications that the foam impact occurred in the panels 6 through 8 area. Two Modular Auxiliary Data System (MADS) lower surface pressure measurements behaved anomalously immediately after the time of the impact. Figure 3-13 shows the location of these measurements along with possible areas for post-impact debris re-contact in the vicinity of the sensors. The unusual behavior of one of the sensors is shown in Figure 3-14.

Unusual behavior of pressure sensor V07P8074A.

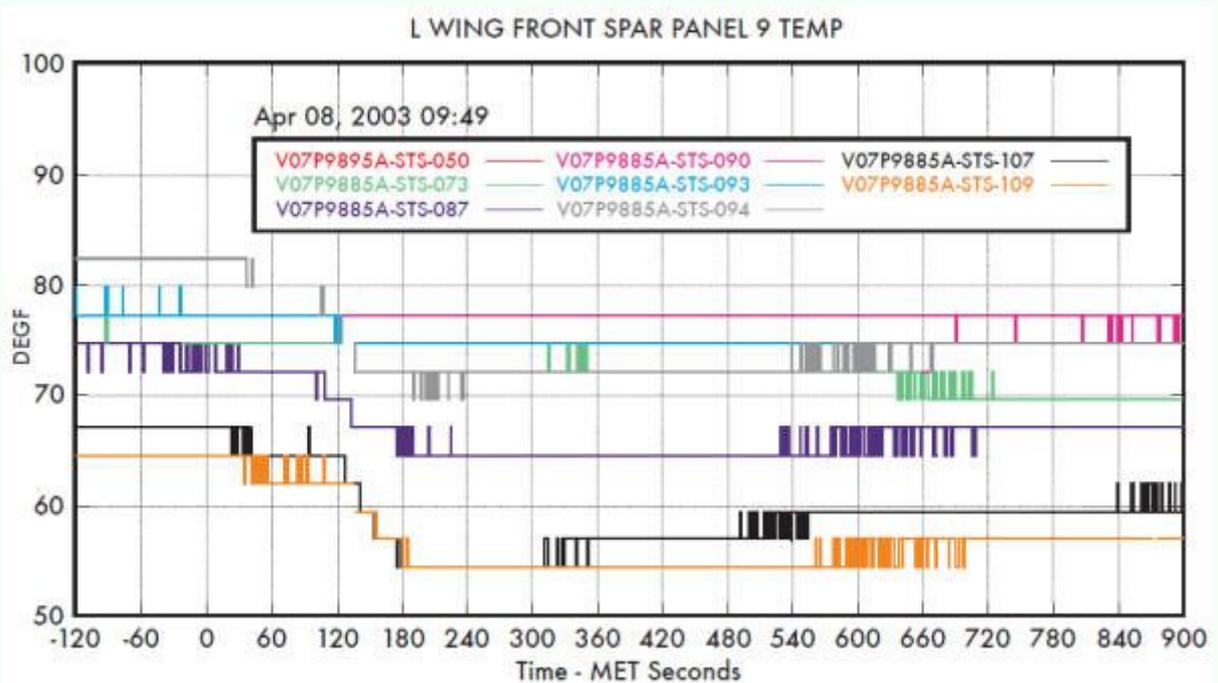
Three-bit rise (7.5 degrees F) on MADS wing leading edge spar temperature measurement (V09T9895A) during ascent. [Figure 3.c.4]

The black line in the graph above denoting STS-107 shows a rise in temperature of 7.5 degrees F, for comparison other flights show a maximum of 2.5 degrees F for the same period of ascent.

STS-107 had a 7.5 degree Fahrenheit rise that started very early during ascent (five to six minutes after launch). Although the data do not prove that the RCC was breached during ascent, the data are consistent with a possible flow path into the RCC cavity via damage in the RCC panels 6 through 8 area. A simplified thermal math model was constructed and verified with flight data from STS-5. The model was then correlated to the flight data from STS-107. Assuming the equivalent heating from a 10 inch diameter hole in RCC panel 8, this model nearly predicts both the ascent and entry temperature profiles for the wing leading edge spar temperature sensor. Figure 3-17 compares the model with the flight data for both ascent and entry. For comparison, Figure 3-18 shows the overall heating rate of the STS-107 ascent and entry environments on RCC panel 9. As shown, the heating on the wing leading edge is much greater during the entry profile than during the ascent profile.

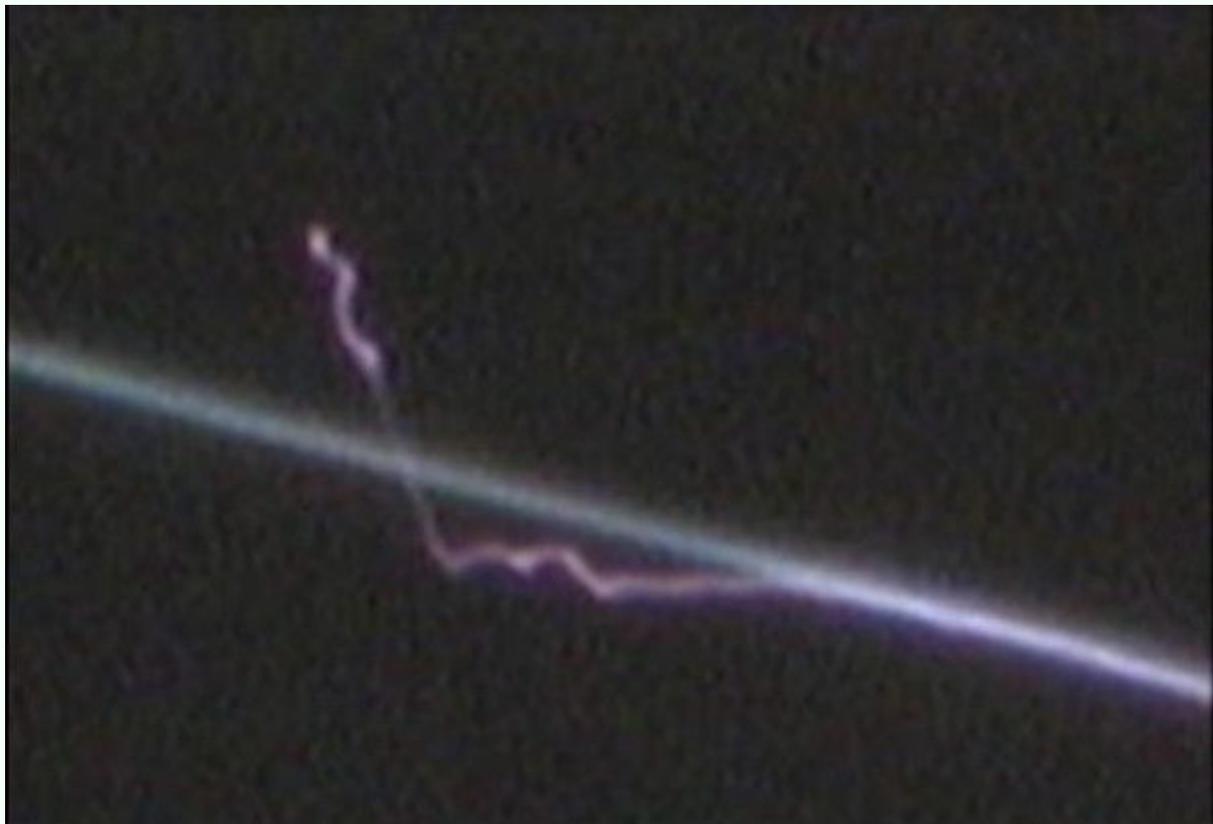
A low resolution copy of the photo under current discussion.

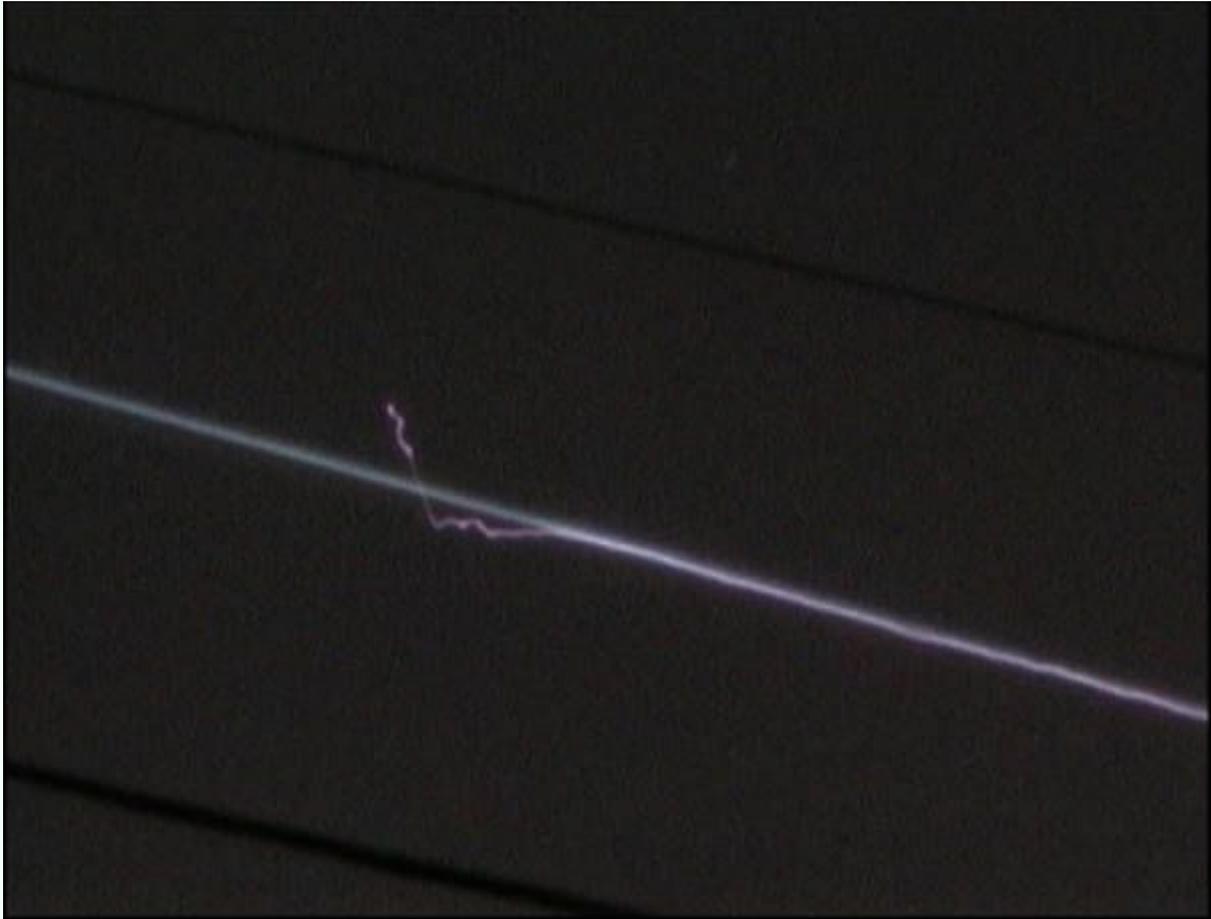
Goldie image #3, close-up and cropped
[Figure 4.e.6]

The dark lines roughly parallel to the plasma trail are powerlines in the foreground. Note the purple hue of the anomaly, and also the apparent "corkscrew" shape to it.

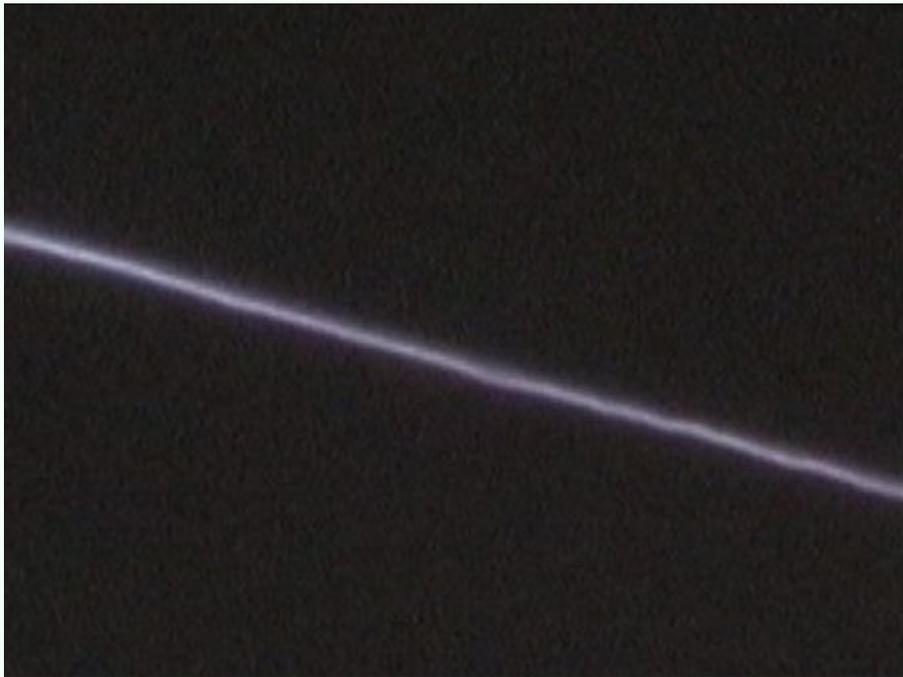
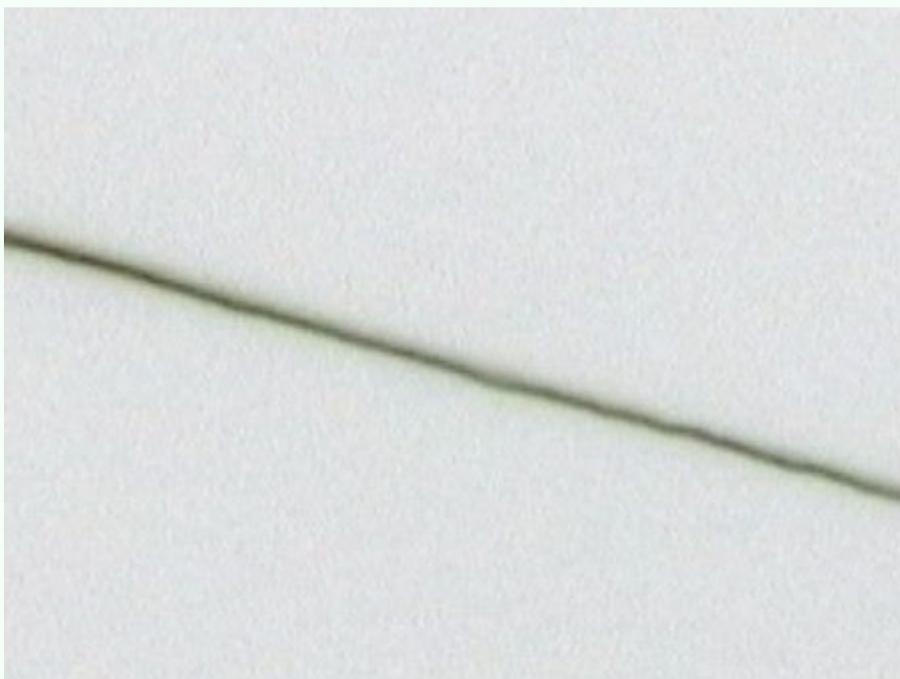
[Figure 4.e.7]

Plasma trail from Goldie image #3.

It seems that in no other image of the plasma-trail left by Columbia, does it exhibit the "wavering" which is seen in this image.

Given that the anomaly was written off as "camera shake" by NASA, the shake should have settled down and stopped, not continued on as is clearly visible in this image.

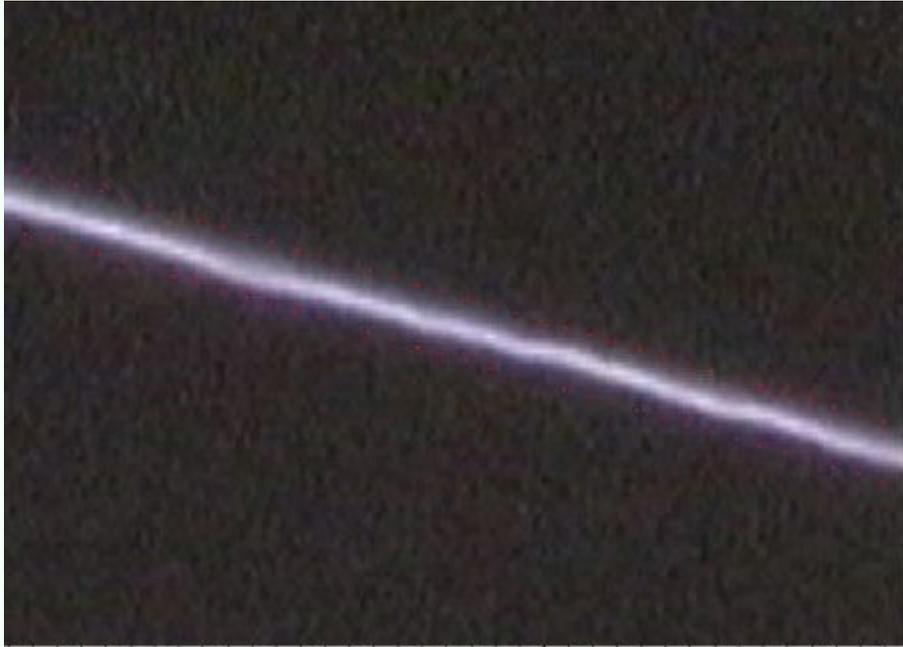
[Figure 4.e.9]

Close-up of the right-hand extreme of the plasma trail, annotated.

There is no logical reason why the orbiter should appear to wobble its way across the sky, whilst the plasma trail remains essentially straight. This author has not seen anywhere, a picture of this or any other space shuttle taken with any device, under any conditions, which exhibits this feature.

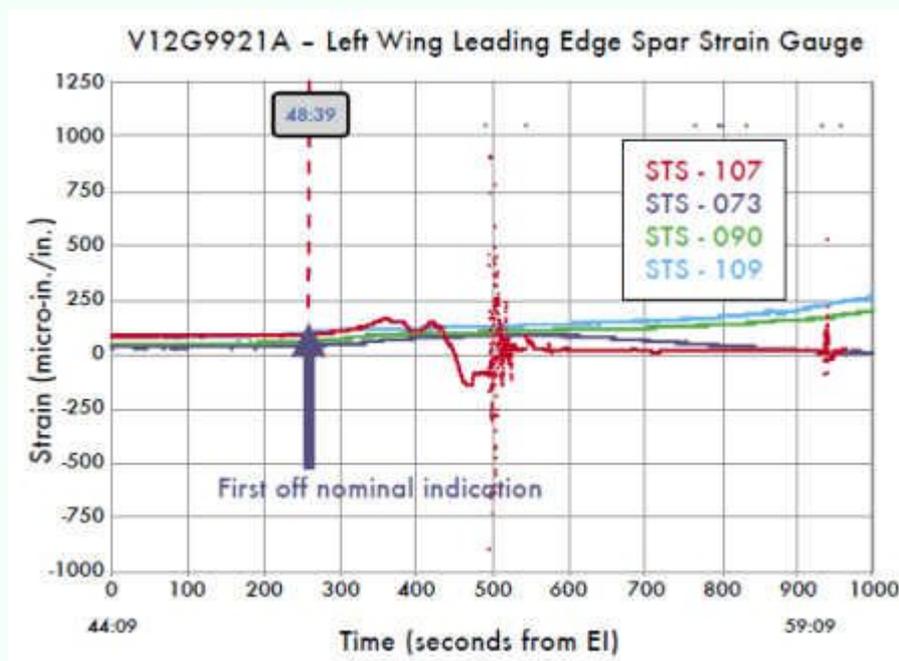
Sensor 1 provided the first anomalous reading (see Figure 3.6-3). From EI+270 to EI+360, the strain is higher than that on previous Columbia flights. At EI+450, the strain reverses, and then peaks again in a negative direction at EI+475. The strain then drops slightly, and remains constant and negative until EI+495, when the sensor pattern becomes unreliable, probably due to a propagating soft short, or "burn-through" of the insulation between cable conductors caused by heating or combustion. This strain likely indicates significant damage to the aluminum honeycomb spar. In particular, strain reversals, which are unusual, likely mean there was significant high-temperature damage to the spar during this time.

The strain gauge (Sensor 1) on the back of the left wing leading edge spar was the first sensor to show an anomalous reading.

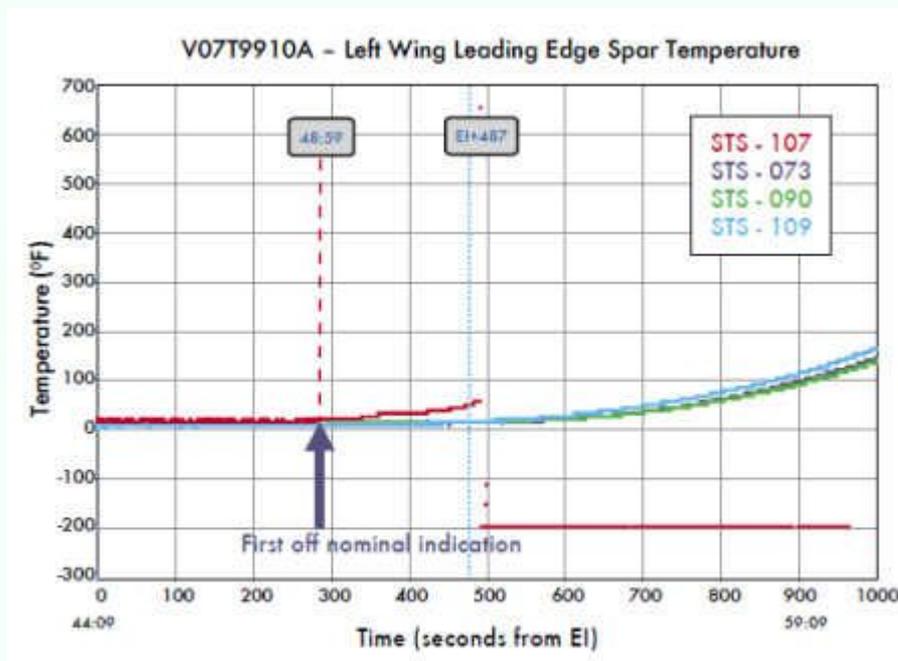
[Figure 4.f.2]

At EI+290, 20 seconds after Sensor 1 gave its first anomalous reading, Sensor 2, the only sensor in the front of the left wing leading edge spar, recorded the beginning of a gradual and abnormal rise in temperature from an expected 30 degrees Fahrenheit to 65 degrees at EI+493, when it then dropped to "off-scale low," a reading that drops off the scale at the low end of

the sensor's range (see Figure 3.6-4). Sensor 2, one of the first to fail, did so abruptly. It had indicated only a mild warming of the RCC attachment clevis before the signal was lost.

This temperature thermocouple (Sensor 2) was mounted on the outside of the wing leading edge spar behind the insulation that protects the spar from radiated heat from the RCC panels. It clearly showed an off-nominal trend early in the re-entry sequence and began to show an increase in temperature much earlier than the temperature sensor behind the spar.

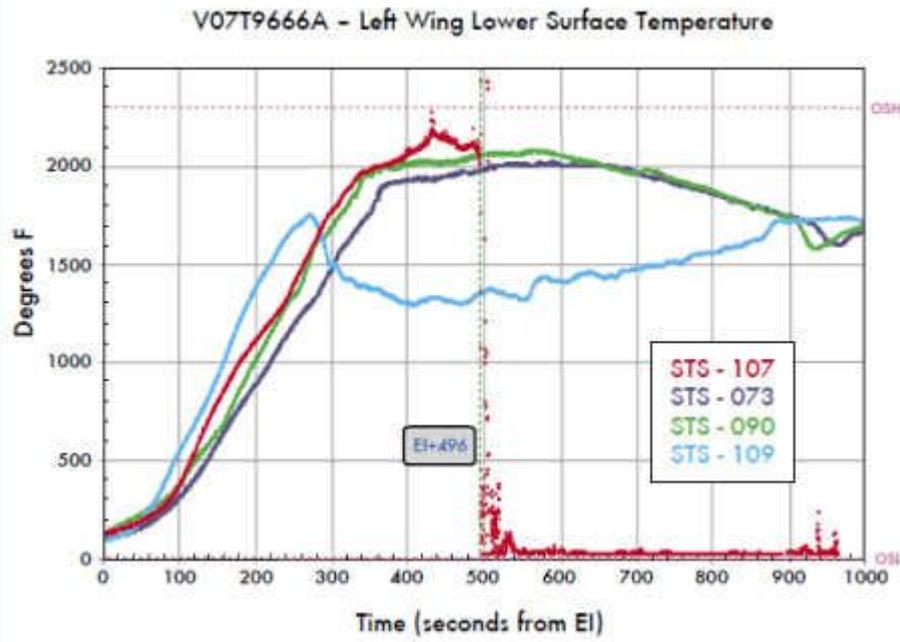
[Figure 4.f.3]

The readings of Sensor 3, which was in a thermal tile, began rising abnormally high and somewhat erratically as early as EI+370, with several brief spikes to 2,500 degrees Fahrenheit, significantly higher than the 2,000-degree peak temperature on a normal re-entry (Figure 3.6-6). At EI+496, this reading became unreliable, indicating a failure of the wire or the sensor. Because this thermocouple was on the wing lower surface, directly behind the junction of RCC panel 9 and 10, the high temperatures it initially recorded were almost certainly a result of air jetting through the damaged area of RCC panel 8, or of the normal airflow being disturbed by the damage. Note that Sensor 3 provided an external temperature measurement, while Sensors 2 and 4 provided internal temperature measurements.

As early as EI+370, Sensor 3 began reading significantly higher than on previous flights. Since this sensor was located in a thermal tile on the lower surface of the left wing, its temperatures are much higher than those for the other sensors.

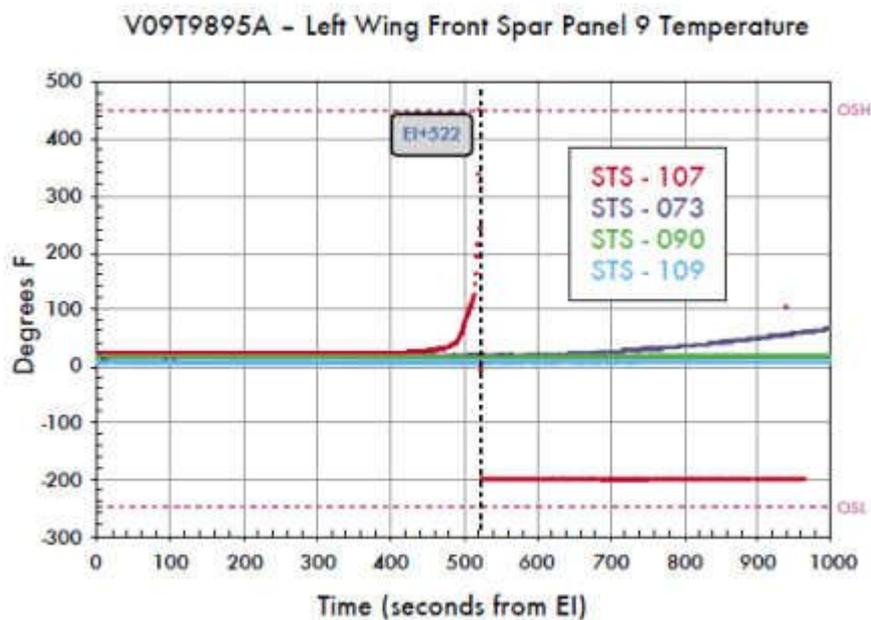
Sensor 4 also recorded a rise in temperature that ended in an abrupt fall to off-scale low. Figure 3.6-7 shows that an abnormal temperature rise began at EI+425 and abruptly fell at EI+525. Unlike Sensor 2, this temperature rise was extreme, from an expected 20 degrees Fahrenheit at EI+425 to 40 degrees at EI+485, and then rising much faster to 120 degrees at EI+515, then to an off-scale high (a reading that climbs off the scale at the high end of the range) of 450 degrees at EI+522. The failure pattern of this sensor likely indicates destruction by extreme heat.

Sensor 4 also began reading significantly higher than previous flights

before it fell off-scale low. The relatively late reaction of this sensor compared to Sensor 2, clearly indicated that superheated air started on the outside of the wing leading edge spar and then moved into the mid-wing after the spar was burned through. Note that immediately before the sensor (or the wire) fails, the temperature is at 450 degrees Fahrenheit and climbing rapidly.
