**Megalightning and
The Demise of STS-107
Space Shuttle Columbia**

*A Fresh Look
at the
Available Evidence*

© 2009 David B. Smith
(aka davesmith_au, davesmith1au)

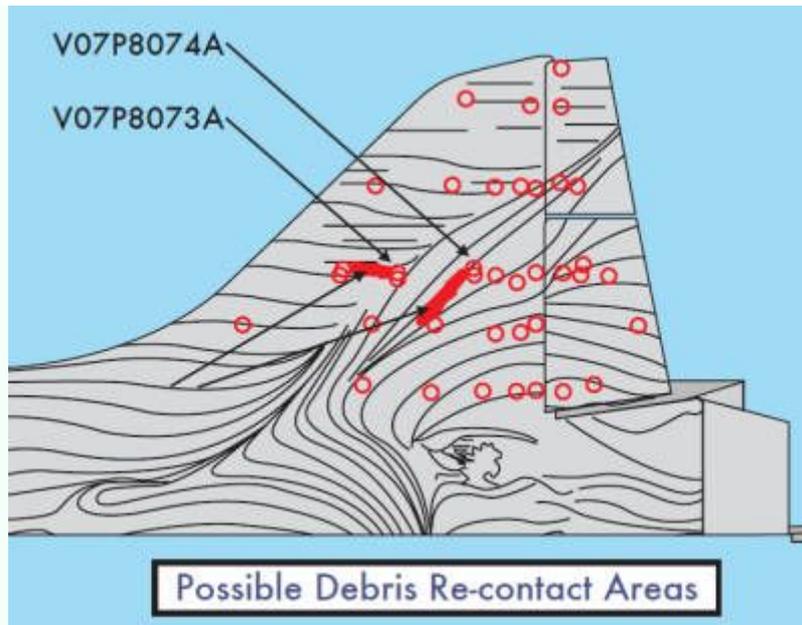
[Figure 3.c.1]

There are two other indications that the foam impact occurred in the panels 6 through 8 area. Two Modular Auxiliary Data System (MADS) lower surface pressure measurements behaved anomalously immediately after the time of the impact. Figure 3-13 shows the location of these measurements along with possible areas for post-impact debris re-contact in the vicinity of the sensors. The unusual behavior of one of the sensors is shown in Figure 3-14.

CFD surface flow with lower left wing pressure sensors.

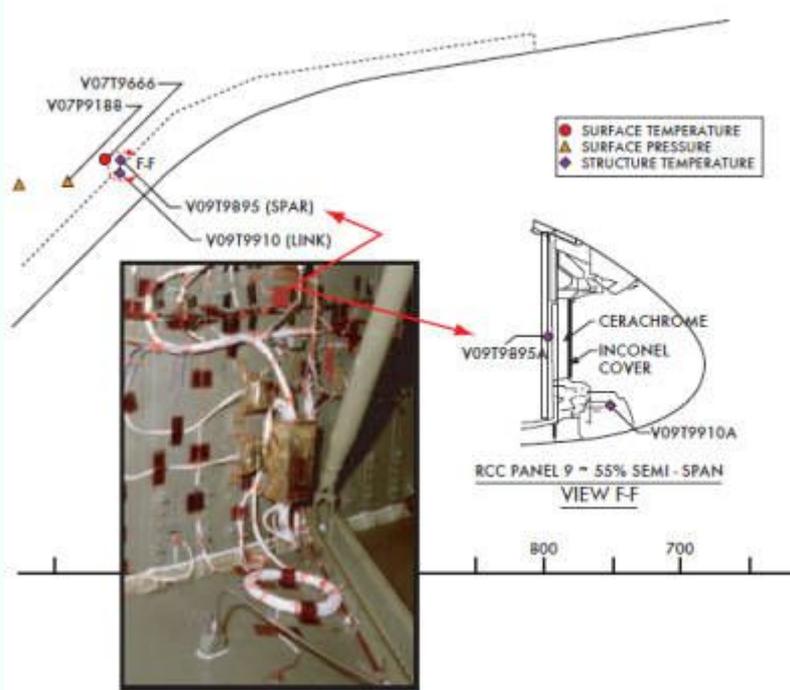
Additionally, there is another MADS measurement that had an off-nominal signature during the ascent timeframe. The temperature sensor on the leading edge spar behind RCC panel 9 showed a slightly higher temperature rise than seen on any previous *Columbia* flight. Figure 3-15 shows the location of the temperature sensor behind the wing leading edge spar inside the wing. The slight temperature rise can be seen in Figure 3-16. Note that most flights show a small rise in this temperature during ascent due to aerodynamic heating.

Close-out photo shows RCC panel 9 wing leading edge temperature measurement. [Figure 3.c.3]

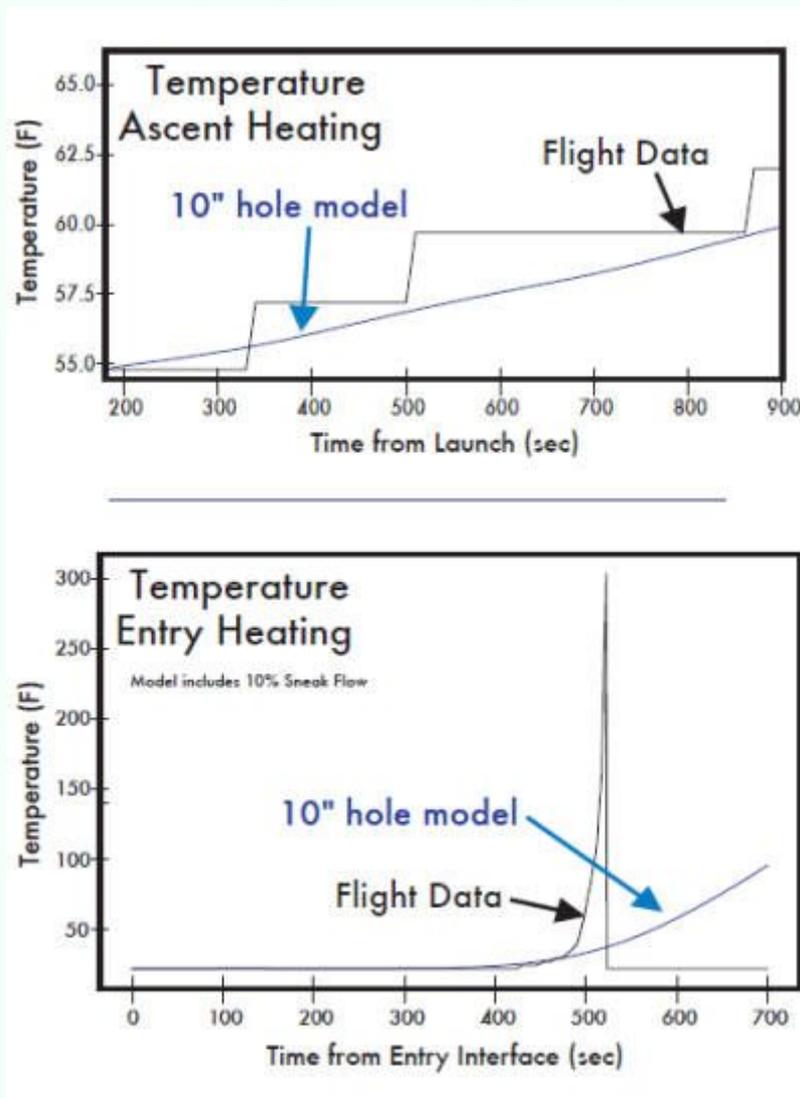
[Figure 3.c.5]

STS-107 had a 7.5 degree Fahrenheit rise that started very early during ascent (five to six minutes after launch). Although the data do not prove that the RCC was breached during ascent, the data are consistent with a possible flow path into the RCC cavity via damage in the RCC panels 6 through 8 area. A simplified thermal math model was constructed and verified with flight data from STS-5. The model was then correlated to the flight data from STS-107. Assuming the equivalent heating from a 10 inch diameter hole in RCC panel 8, this model nearly predicts both the ascent and entry temperature profiles for the wing leading edge spar temperature sensor. Figure 3-17 compares the model with the flight data for both ascent and entry. For comparison, Figure 3-18 shows the overall heating rate of the STS-107 ascent and entry environments on RCC panel 9. As shown, the heating on the wing leading edge is much greater during the entry profile than during the ascent profile.

Correlation between simplified thermal math model and STS-107 ascent and entry flight data.

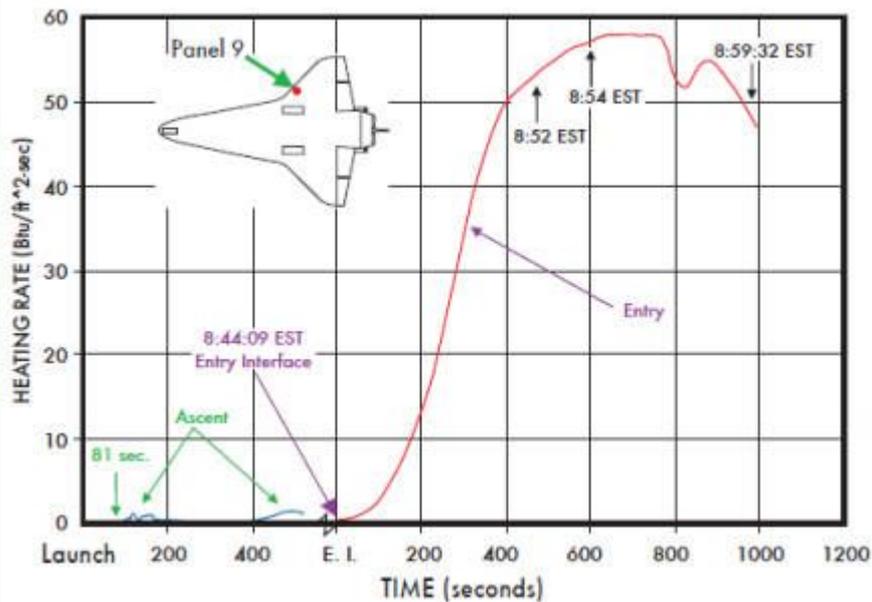
STS-107 ascent and entry heating environments on RCC panel 9.
[Figure 3.c.6]

Although the ascent anomalies were small in nature, they were 'out of family' in comparison to all previous Columbia launch data, further strengthening the case for the foam strike damage scenario.

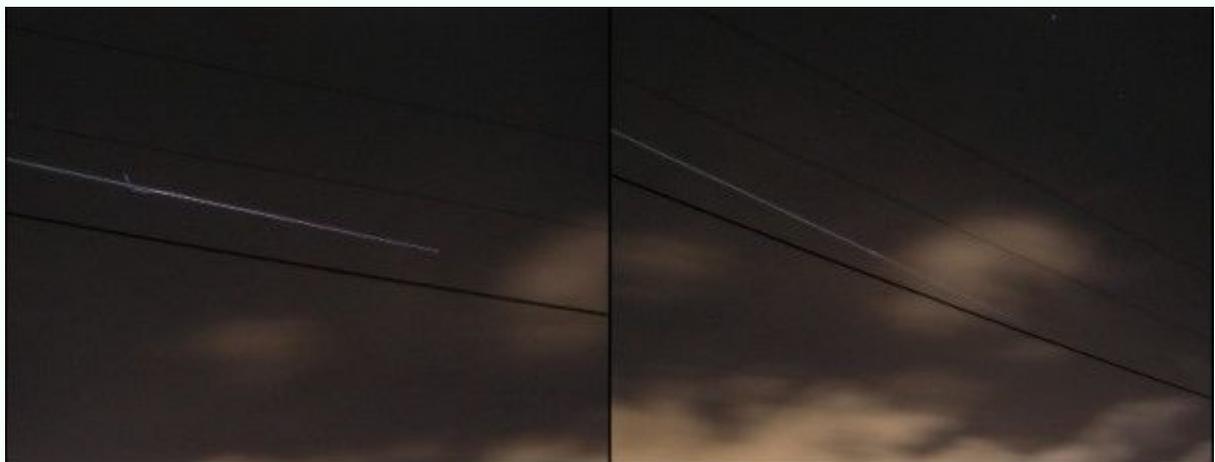
Some more screen grabs from the documentary "Megalightning". These are the five images which Amateur Astronomer Peter Goldie took of Columbia's reentry, presented here in the order in which they were taken. The anomaly under

discussion is on the third image of the sequence.

Goldie images 3 and 4 of 5
Credit: [dmptv](#)/Peter Goldie
[Figures 4.e.3 & 4.e.4]

One can not help but ask why the exact time the image was taken was not calculated. The only answer I can deduce from the CAIB Report is that the image was considered unimportant because of the 'anomaly' being explained away as camera shake. But this explanation again fails to account for the apparent "crispness" of the stars in the image, and in fact the powerlines appear to be rendered the same in all of the images taken by Goldie. Image #3 does not display any blurring of either the powerlines or the stars due to camera shake.

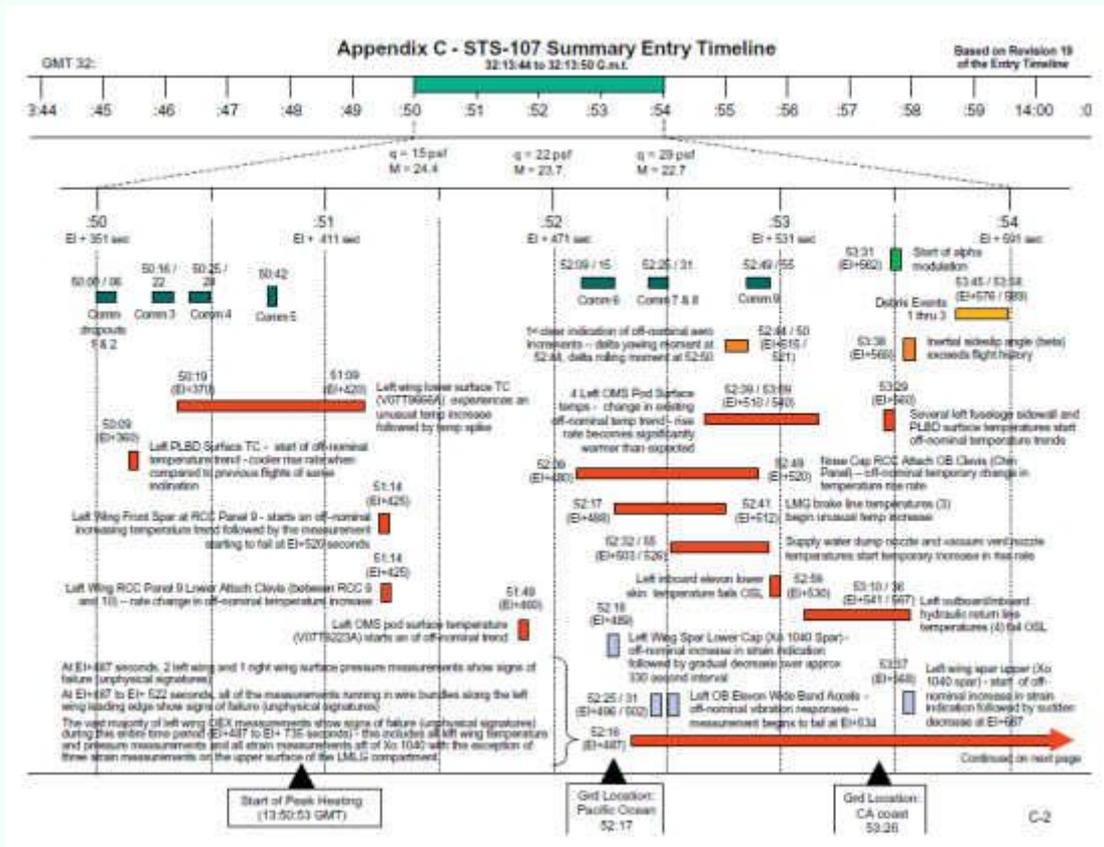
Now if we look at the entry timeline data in chart form, things become clearer. Comms event 10 is indicated below by the green vertical block at EI+562.

Reentry timeline data
[Figure 4.f.5]

The first visual sighting of debris shedding was some 14 seconds after Communications event 10, at 8:53:46 or EI+576
